Manhole Inspection Summary

Manhole # S15G__001MH

Insp Date: **2/26/08 8:52 AM**

Location Address: **2712 alley-fairmount-kinsey** Cross Street: **franklintown rd**

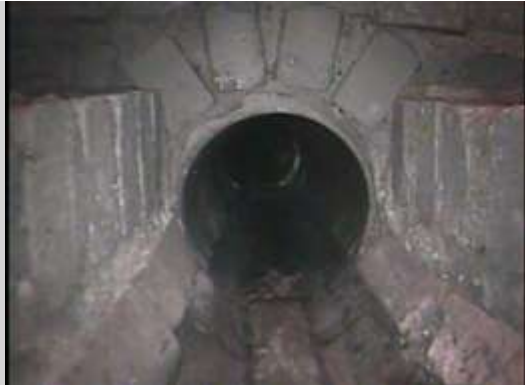
12 O'Clock Outflow

8 in. Circular Gravity Sewer
Pipe Out @ 12 O'Clock

Pipe Height: **8.4** (in.) Rod and Bar (Angled)
Pipe Material: **Clay** ☐ Pipe Lined
Invert Depth: **9.12** (ft.) Flow Characteristics: **Slow**
Deposits: ☒ None ☐ Mud ☐ Sludge ☐ Debris ☐ Grease
Silt Depth: **0** (in.) Deposits Extent:
Infiltration: **None** Pipe Seal Cond: **Sound**

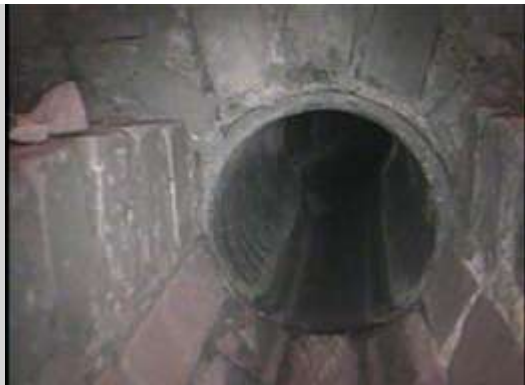
6 O'Clock Inflow

8 in. Circular Gravity Sewer
Pipe In @ 6 O'Clock

Pipe Height: **8.4** (in.) Rod and Bar (Angled)
Pipe Material: **Clay** ☐ Pipe Lined
Invert Depth: **8.92** (ft.) Flow Characteristics: **Slow**
Deposits: ☒ None ☐ Mud ☐ Sludge ☐ Debris ☐ Grease
Silt Depth: **0** (in.) Deposits Extent:
Infiltration: **None** Pipe Seal Cond: **Sound**

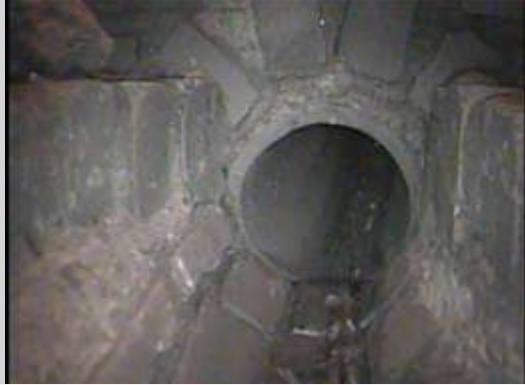
9 O'Clock Inflow

6 in. Circular Gravity Sewer
Pipe In @ 9 O'Clock

Pipe Height: **6** (in.) Rod and Bar (Angled)

Pipe Material: **Clay** ☐ Pipe Lined
